## Half-Joint Risk Management Report - Underbarrow

Document no: BCU00015-JAC-SBR-6330-RP-SL221-CB-001  
Revision no: P04

Westmorland & Furness Council  
6330

Risk Management and Structural Assessment of Post Tensioned and Half-joint Bridges SL240 Brigsteer and SL221 Underbarrow  
17 July 2024

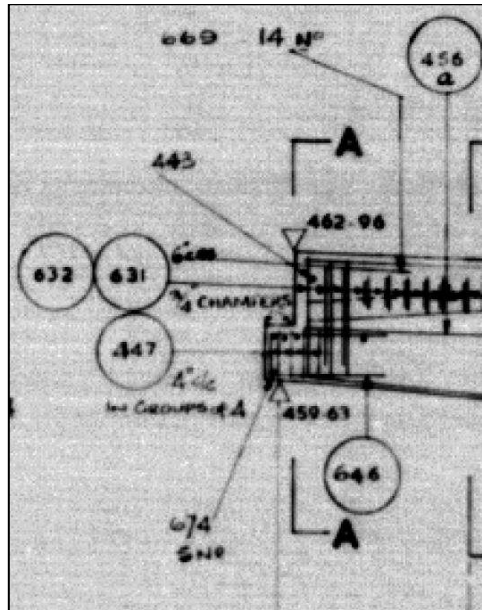
**Figure 3 – Underbarrow East Half-Joint**

The historical drawings do not show the size of each bar mark and call off spacings of bar marks sporadically. There are no accompanying bar bending schedules to indicate sizes, shapes and numbers of bars for each bar mark.

Showing reinforcement layout of lower nib.

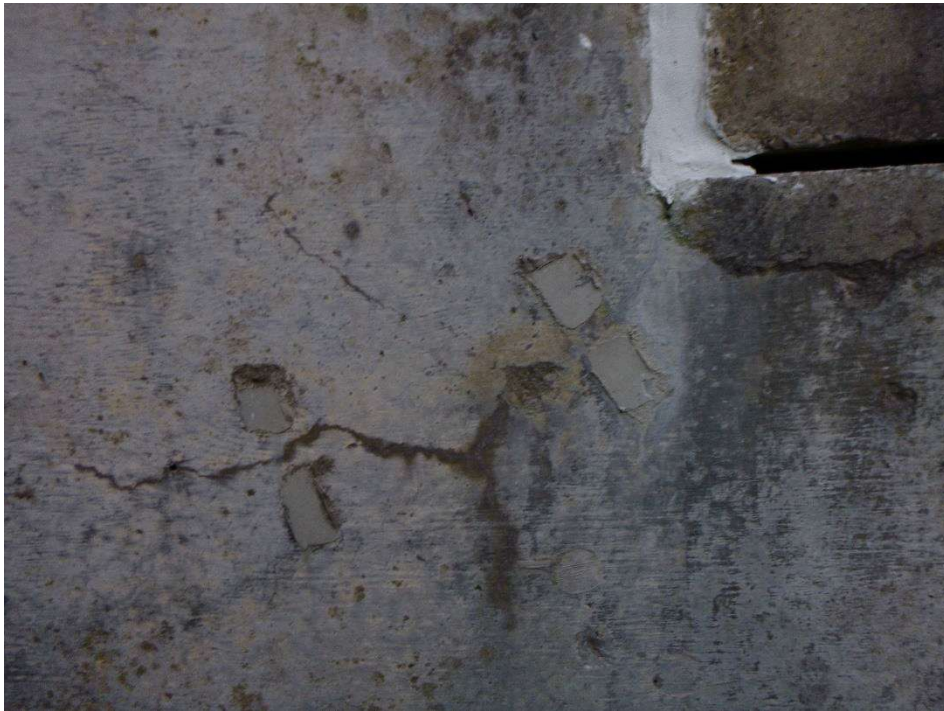
| Defect Description | Reference | Defect Identification | Zone (see Figure 8) | Damage Rating | Defects in Combination |
|---|---|---|---|---|---|
| Shrinkage cracks behind lower nib re-entrant corner | Appendix B, Photograph 1 | North east half-joint | 4 | Very slight | |
| Shear crack to lower nib re-entrant corner | Appendix B, Photograph 1 | North east half-joint | 3 | Very slight | |

Photograph 1 - Close up on cracking to north-east half-joint

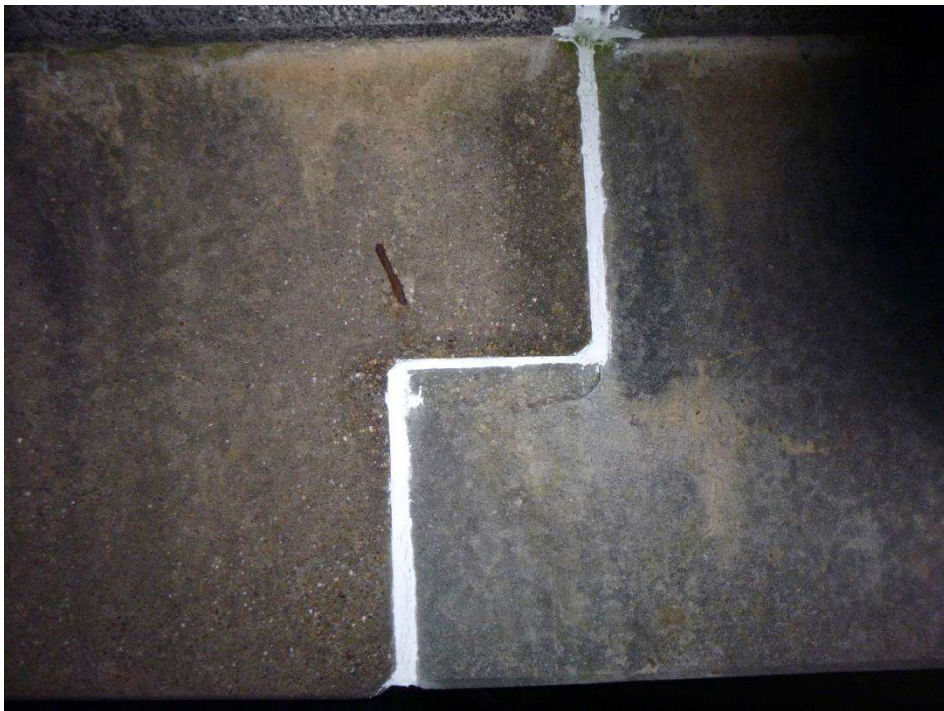
| Defect Description | Reference | Defect Identification | Zone (see Figure 8) | Damage Rating | Defects in Combination |
|---|---|---|---|---|---|
| 0.4mm Shear crack to lower nib re-entrant corner | 2018 PI Text (not confirmed Appendix B, Photograph 2) | South east half-joint | 3 | moderate | |

Photograph 2 – South-east half-joint. Note, previous repair and exposed reinforcement.

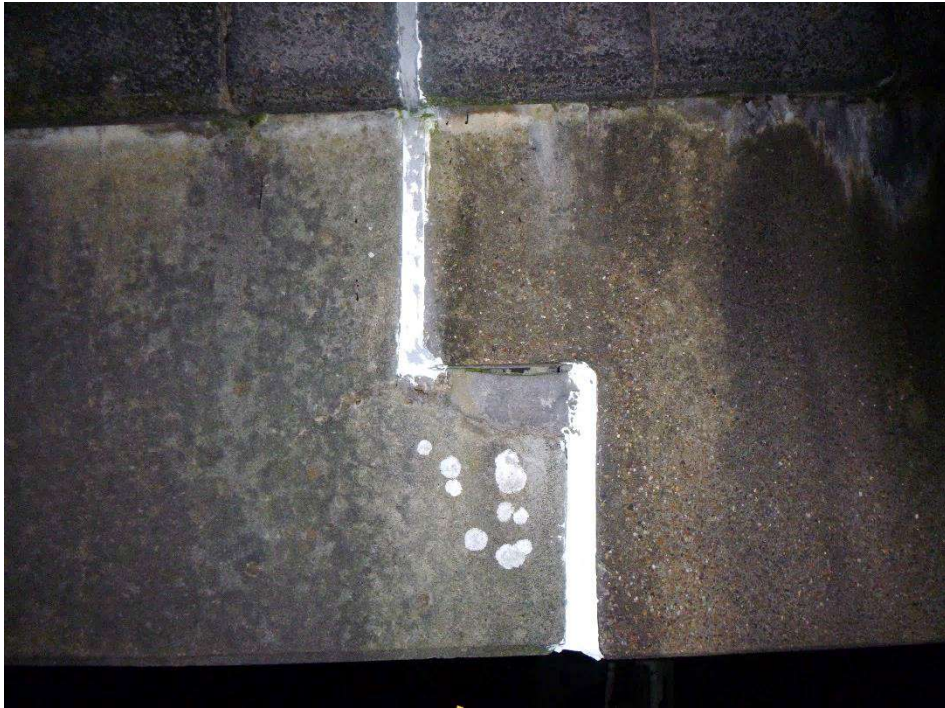
| Defect Description | Reference | Defect Identification | Zone (see Figure 8) | Damage Rating | Defects in Combination |
|---|---|---|---|---|---|
| Localised spot spalls | Appendix B, Photograph 3 | South west half-joint | 2 | Very slight | |

Photograph 3 – South-west half-joint. Note, previous repair and minor spalls.

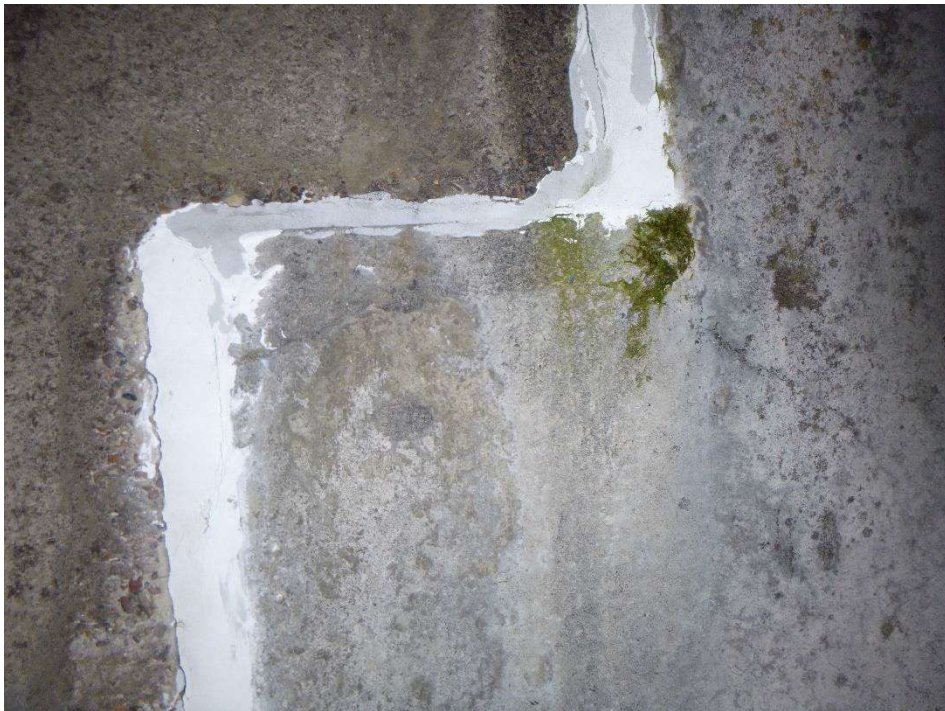
| Defect Description | Reference | Defect Identification | Zone (see Figure 8) | Damage Rating | Defects in Combination |
|---|---|---|---|---|---|
| Hollow sounding concrete to lower nib | Appendix B, Photograph 4 | North west half-joint | 3 | Very slight | Water staining |

Photograph 4 - Algal staining and previous repair to north-west half-joint. Note, the joint is fully sealed.

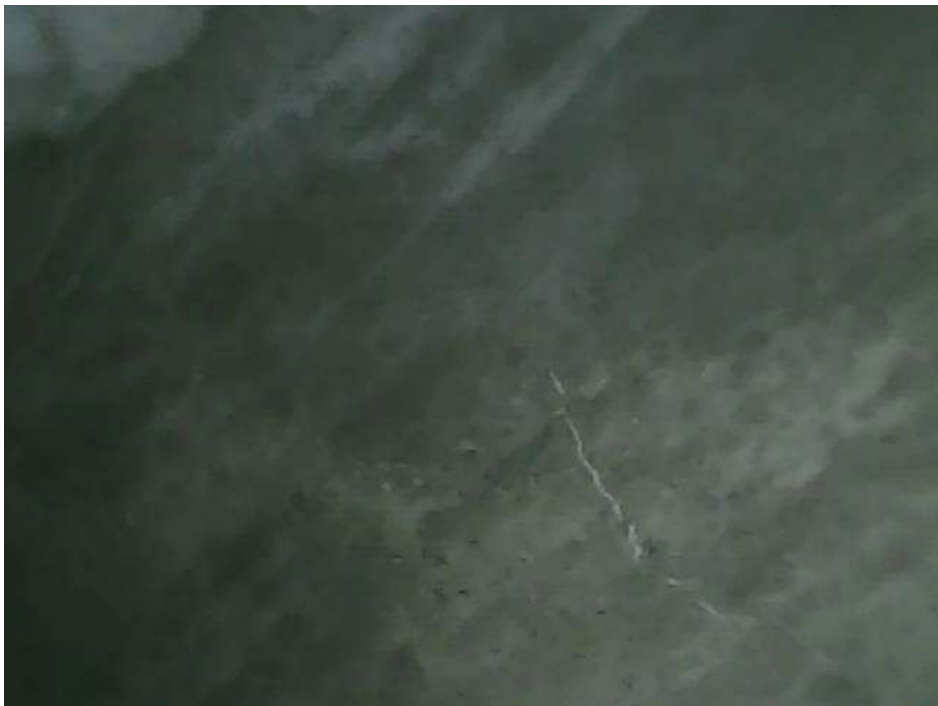
| Defect Description | Reference | Defect Identification | Zone (see Figure 8) | Damage Rating | Defects in Combination |
|---|---|---|---|---|---|
| Cracking to lower nib and chamfer at re-entrant corner within half joint. | Appendix B, Photographs 6-9 | Within east half joint, observed at north and south ends. | 2 / 3 | Very slight | |

| Defect Description | Reference | Defect Identification | Zone (see Figure 8) | Damage Rating | Defects in Combination |
|---|---|---|---|---|---|
| Cracking to lower nib and chamfer at re-entrant corner within half-joint. | Appendix B, Photographs 6-9 | Within east half-joint, observed at north and south ends. | 2 / 3 | Very slight | |

Photograph 6 - Crack to lower nib (north elevation)

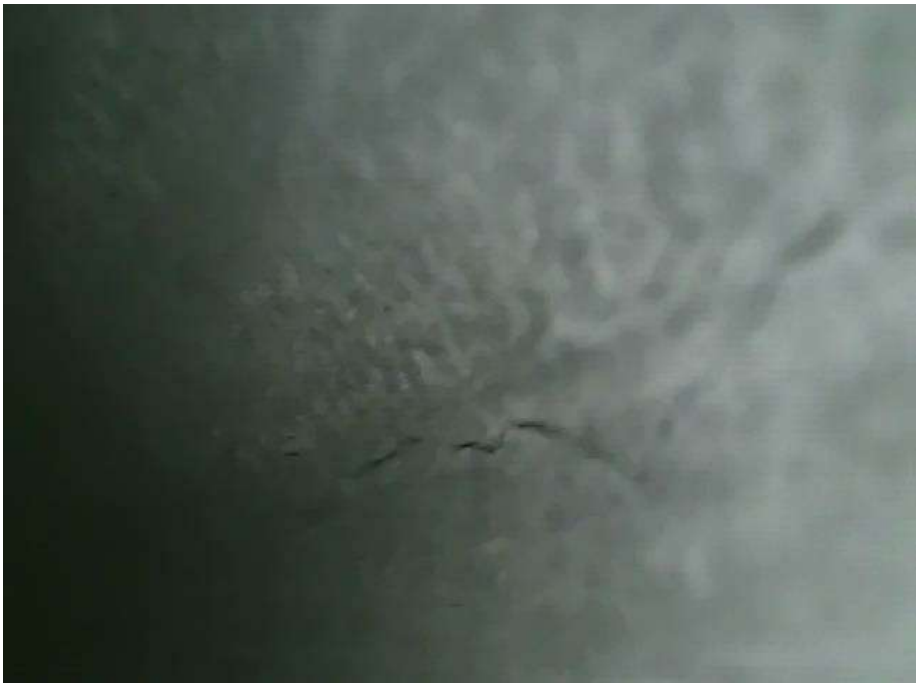
Photograph 7 - Second crack to lower nib

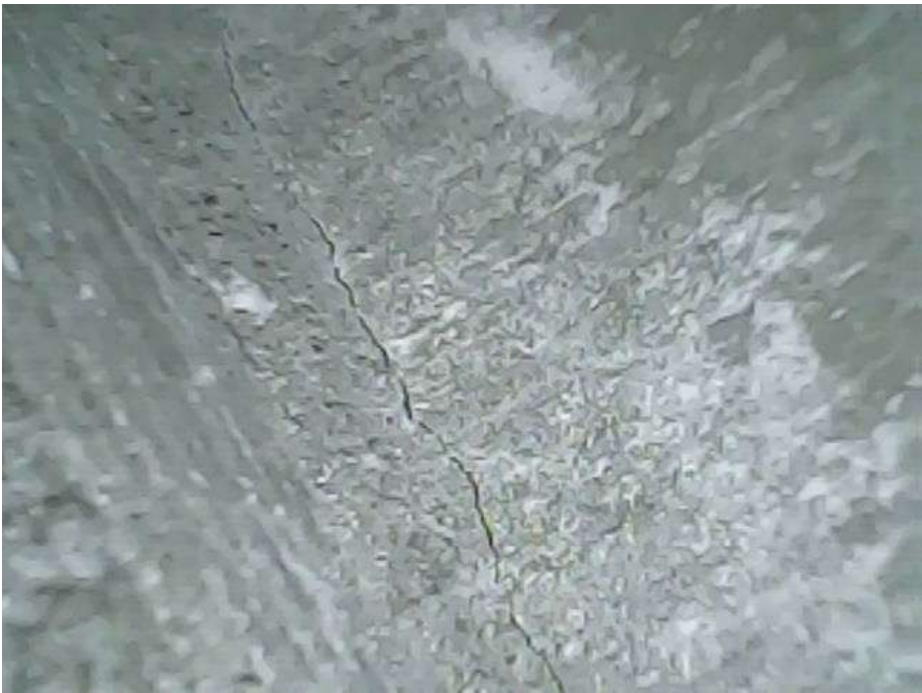
Photograph 8 - Crack to lower nib (2<sup>nd</sup> beam from south)

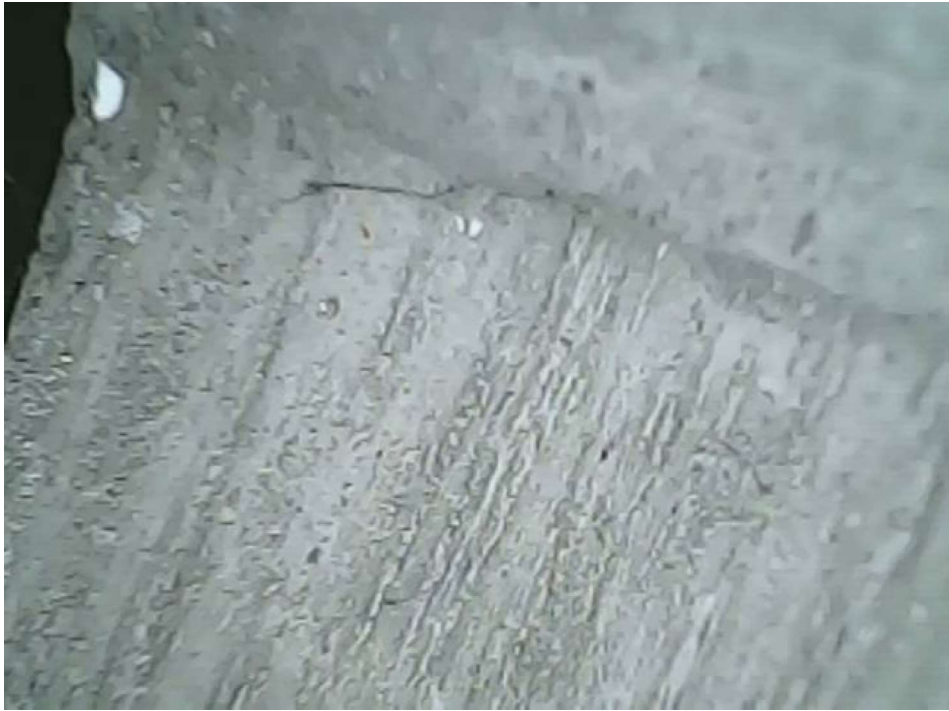
Photograph 9 - Crack to lower nib of south box beam.

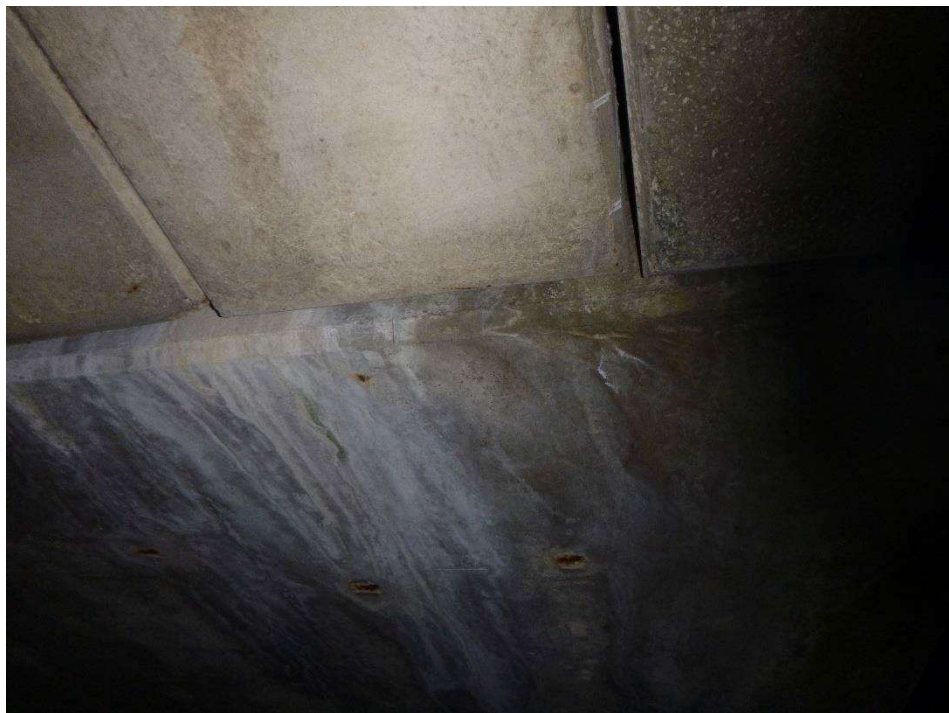
| Defect Description | Reference | Defect Identification | Zone (see Figure 8) | Damage Rating | Defects in Combination |
|---|---|---|---|---|---|
| Localised spalling to soffit | Appendix B, Photograph 10 | North | 1 | Very slight | Leachate staining |

Photograph 10 - Leachate staining to deck soffit.
